OCTEON II CN66XX Known Issues

Version: 1.5

Last modified: 31 May 2012

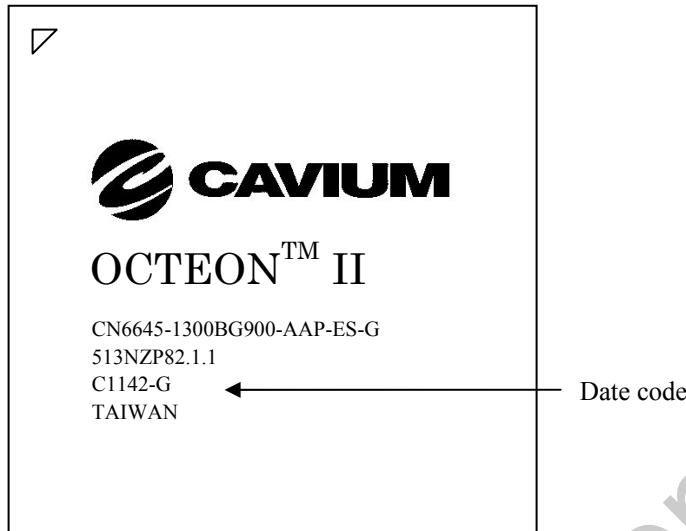
1.2.1 Date Code Markings

The date code shown is indicating a pass 1.2 part. Pass 1.0 parts have a date code with no letter prefix, similar to “1108-G”.

The revision number for CN66XX-family parts are marked on the case as part of the date code. The information is also available from the PrID register, and from the PCI Express device revision ID.
